Selection of Engine Oils with Tribological Examinations Applicable to Specially Operated Diesel Engines

Keywords: internal combustion diesel engine, engine oil, tribological examination

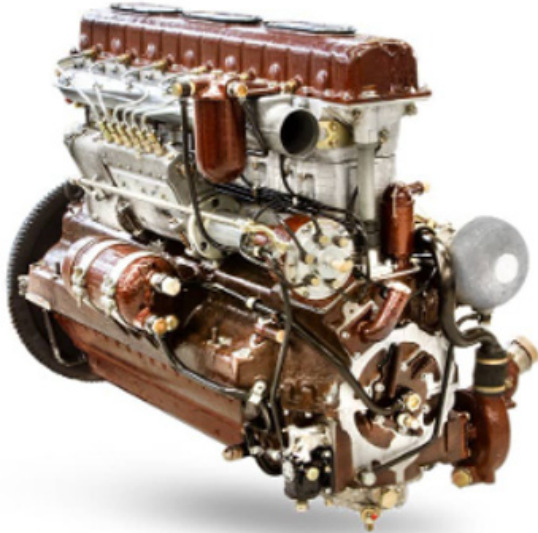
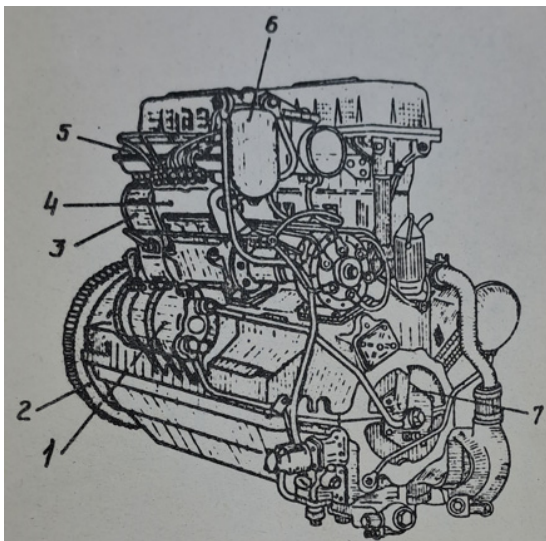
Figure 1. V-6M type diesel engine (top) and main parts of the engine (bottom) [9] 1- oil filter; 2- flywheel; 3- RPM regulator; 4- fuel pump; 5- intake pipe; 6- fuel filter; 7- central oil distributor.

Before our research work, we examined several older built, however, today also operated, high-performance diesel engines. We chose a V-6M-type engine (Figure 1.) because factory oil remainings were found for this engine that was enough to perform tribological investigations.

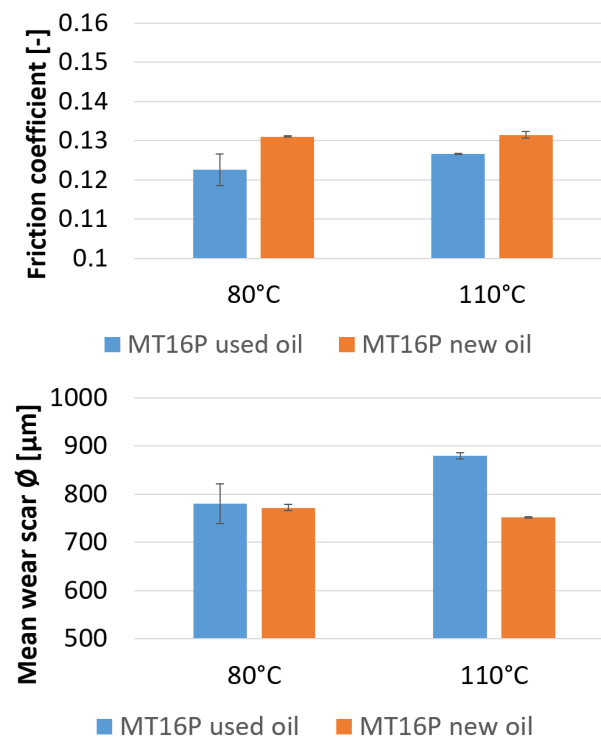
Figure 2. Friction coefficient (top) and mean wear scar diameter (bottom) comparison of used and new oil sample of MT16P on 80 and 110°C testing temperatures. (Source: Authors compilation)

Figure 2 illustrates the comparison of the used oil sample taken from the V-6M type engine with 50 working hours and its reference oil sample with 0 working hours on two different measurement temperatures. Different tendencies can be defined in the case of the friction coefficient and mean wear scar diameter values: lower friction coefficient values were detected in the case of the used oil sample compared to the new one, while the opposite tendency can be defined in the case of the measured mean wear scar diameter values. It is evident from the measured data, that the measured values are higher in the case of the 110°C testing temperature with the used oil, however the new oil works similarly in the case of both temperatures. This result proves that this engine lubricant is designed to protect the contacting surfaces under multiple temperature conditions during engine operation. Used oil provides lower friction but more wear, which can usually be explained by a measurable value of fuel or coolant in the engine oil, which decreases the kinematic viscosity of the lubricant. This decreased viscosity leads to decreased frictional losses because less energy is needed to move the oil molecules, but this process increases the wear because of the thicker oil film between the contacting surfaces. This is the reason why the chemical lubricant analysis is crucial because this hypothesis can only be proved with this kind of measurement.

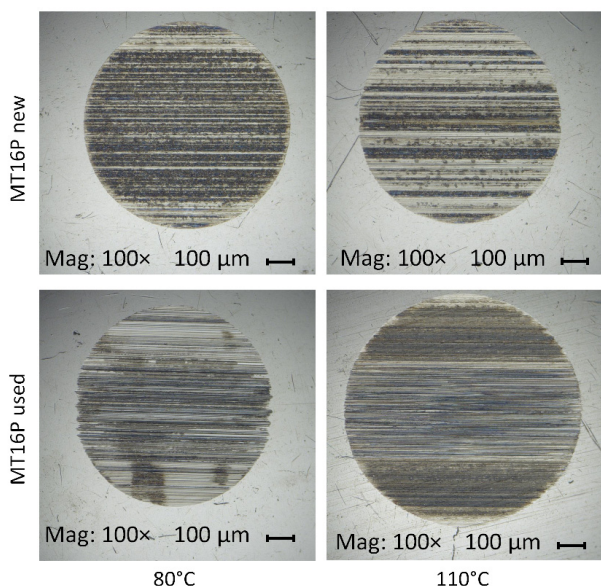
Figure 3. Digital microscopic wear images on the ball specimens in the case of measurements with new (top) and used (bottom) MT16P type of engine oil under 80°C (left column) and 110°C (right column) temperature, acquired with 100× magnitude. (Source: Authors compilation)

Figure 3 represents the acquired digital microscopic images of the ball specimens after measurements with unused and used MT16P lubricant samples under the two investigating temperatures. It can be defined that the most dominant wear mechanism is abrasion because the loss of wear grooves parallel to the sliding move-

ment is visible. Besides, a significant amount of fatigue wear holes can only be identified on the surfaces in the case of the unused lubricant. This fatigue wear is not present in the case of the used lubricant, probably because of the soot and wear particles that are present in this lubricant sample.

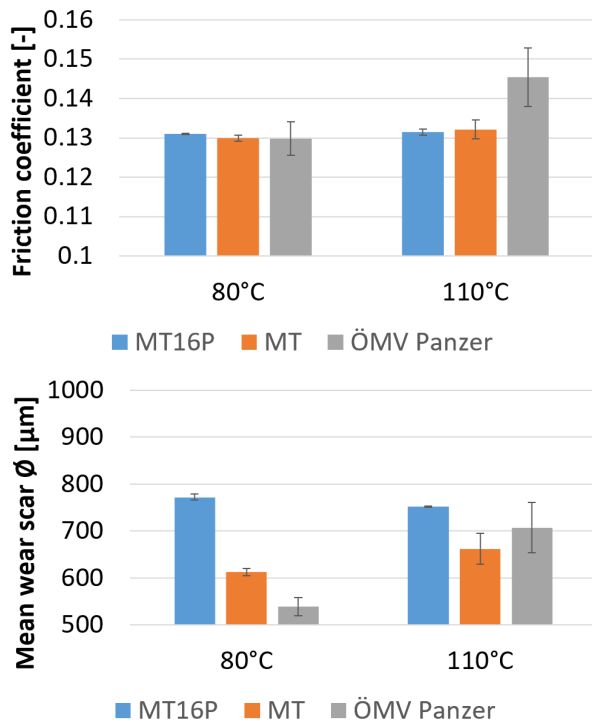
Figure 4. Friction coefficient (top) and mean wear scar diameter (bottom) comparison of new oil sample of MT16P, MT, and ÖMV Panzer 20W50 engine oils on 80 and 110°C testing temperatures. (Source: Authors compilation)

Figure 4 presents the measured friction coefficient (top) and mean wear scar diameter (bottom) values in the case of the oil variations under two testing temperatures. It is clearly visible that each lubricant variant operates with a friction coefficient of around 0.13, however, the ÖMV Panzer shows an increased value under 110°C testing temperature (approximately 10% increase). The tendency is unclear when the mean wear scar diameter values are observed: the original MT16P is not a temperature-dependent liquid, while its commonly used alternatives do so (MT variation 8%, while ÖMV Panzer variation 30% MWS D increase). However, both alternative oil samples provide lower wear losses than the original, which correlates with the continuous development of the engineering and chemistry areas. It is essential to mention that the tribological results are significantly viscosity-dependent. Hence, the friction and wear results are sometimes difficult to compare, especially in the case of the MT variation, because its viscosity is assumed to be lower, based on the analog first-sight observation. Analysing the ÖMV Panzer 20W50 and its application, clearly proves that this type of engine oil was mainly produced for military engine applications where a low amount of wear and lifetime have higher priority than the decrease of frictional losses and so increased fuel efficiency.

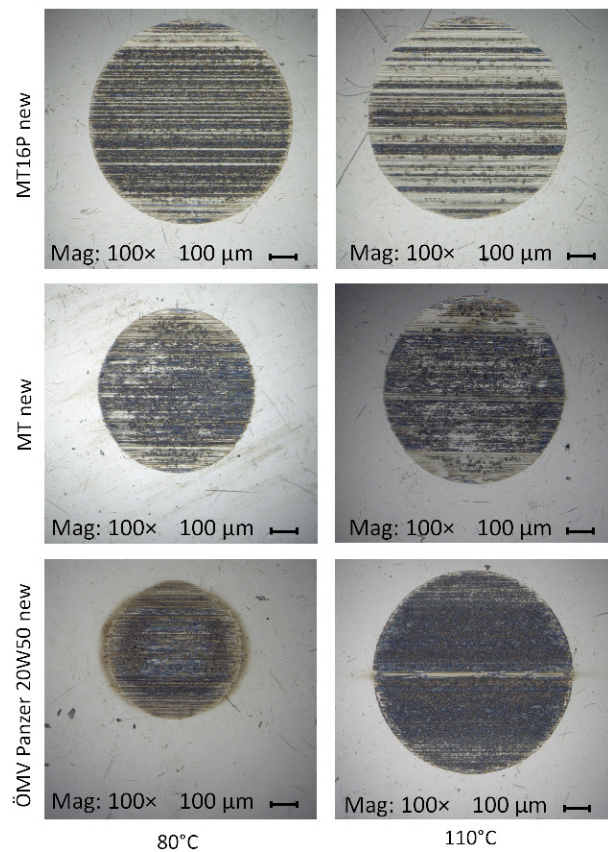
Figure 5. Digital microscopic wear images on the ball specimens in the case of measurements with MT16P (top), MT (middle), and ÖMV Panzer (bottom) type of engine oil under 80°C (left column) and 110°C (right column) temperature, acquired with 100x magnitude. (Source: Authors compilation)

Figure 5 represents the acquired digital microscopic images of the ball specimens after measurements with unused MT16P, MT, and ÖMV Panzer lubricant samples under the two investigating temperatures. The digital microscopic images show an interesting tendency: the amount of the visible, parallel to the sliding direction wear grooves, slightly decreased in the case of MT lubricant variation, and significantly decreased in the case of ÖMV Panzer sample. Furthermore, the area of black regions on the surfaces is also higher in the case of the MT and ÖMV variation, representing burned oil on the surfaces. It can be explained by the lower amount of wear (wear depth) because a slight amount of oil burning is a natural behavior during these tests, but an increased depth of wear removes this layer and reveals the metal-colored surface via abrasion.

The removed or thinned oil layer from the surface is a self-generating process, because the surface cannot be protected via this layer accordingly and the continuously increasing amount of removed material from the contacting surfaces increases the wear depth. It also can be defined that just a tiny amount of wear grooves can be observed in the case of the ÖMV Panzer variation, the surface seems to be plainer (similar to ground surfaces), which shows better wear protection property of this sample. The results of the LubCheck analysis should be analyzed to find the explanation for these observations.

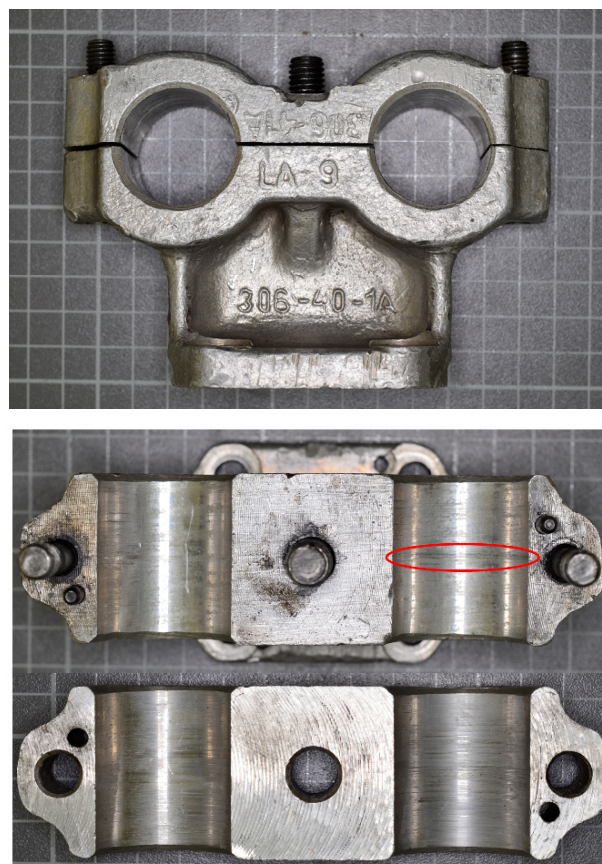
Figure 6. Camshaft bearing module and its bearing surfaces of the investigated V-6M engine type. (Source: Authors compilation)

A used camshaft bearing module was available for the authors to analyze what happens during the engine's operation. This camshaft bearing module worked inside an engine used for an electricity generator device which was operated with the previously introduced MT type of engine oil. This module is completely manufactured from aluminum alloy, even the bearing surface as well, while the camshafts are manufactured from iron alloy. Figure 6 shows the investigated camshaft bearing module and its bearing surfaces. The bearing surfaces were in a bad condition because a significant amount of wear could be identified without any microscopes: there is a vast wear groove in the middle area of the bearing surface (red marking in Figure 6.), and the whole bearing surface shows some interesting wear pattern, which should be further analyzed.

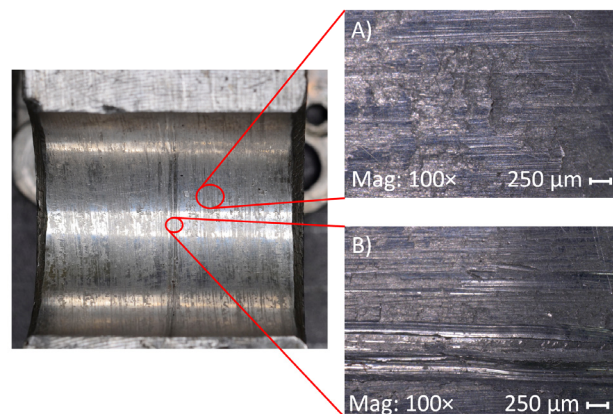
Figure 7. Digital microscopic images about the bearing surface of the investigated module were acquired with 100× magnitude. (Source: Authors compilation)

Figure 7 illustrates the acquired digital microscopic images of the bearing surface of this module and their location. The heavily damaged bearing surface was mainly analyzed (marked with a red ellipse in Figure 6), and two different wear pattern areas were identified there: the normal wear of this bearing surface is fatigue wear (Figure 7 A) and local but deep abrasive wear (Figure 7 B.). The fatigue wear could arise from the insufficient lubrication status of this bearing where the bearing surface experienced higher contact pressure and temperature, resulting in a network of cracks in the outer micrometer depth of the surface, and this led to a material removal of these weakened surface layers as microparticles. These microscopic wear particles usually have higher hardness (because of self-hardening via

contact temperature increase), and these particles could cause increased three-body abrasion wear on the surface [7], as is clearly visible in Figure 7 B).

The investigation of the bearing surfaces of a camshaft bearing module taken from a V-6M engine operated as an electric generator (operated with the MT variation of engine oil) revealed an interesting phenomenon: a significant amount of fatigue wear, including some deep abrasive grooves, is visible on the contacting surfaces and both wear mechanisms could be traced back to lubrication anomalies. This type of engine operated with MT oil variations can produce oil pressure drops during its operation (that is the reason why the engine oil should be replaced earlier in these engines), and this oil pressure drop can cause a high amount of fatigue wear, and three-body abrasion grooves as well.
