# Effects of Residual Ni60 Spray Particles on Structured-Blue-Light Scanning Accuracy of Helical Gears

**Keywords:** Helical gear; Laser cladding; Residual spray particle; Structured blue-light scanning; Surface completeness.

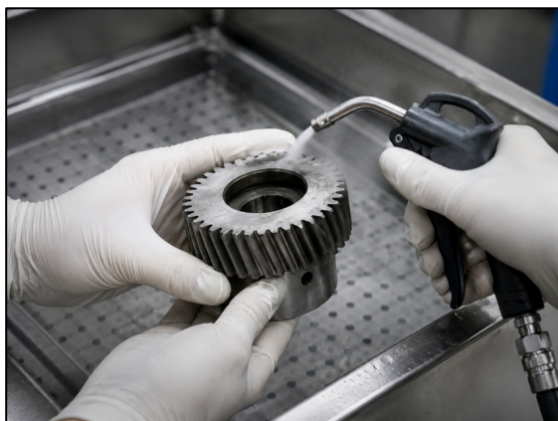
**Figure 2. Maintenance Cleaning of Original Helical Gear**

Step 01: Clean the original helical gear thoroughly via ultrasonic cleaning and high-pressure dry air blowing,

ensuring that no residual spray particles adhere to the entire tooth surface. The cleaning process is shown in Figure 2.

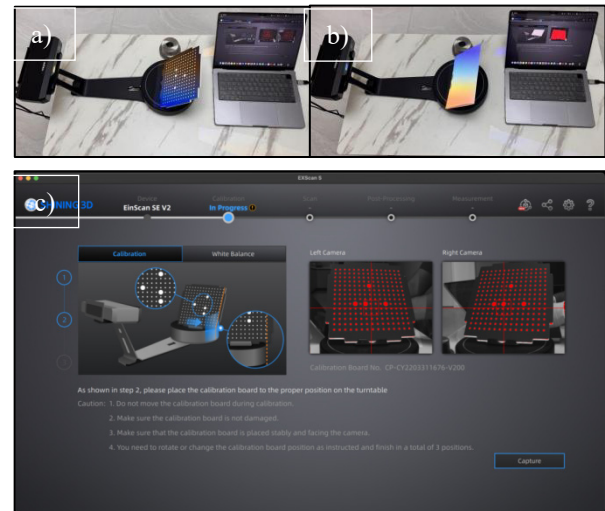
**Figure 6. a) Calibration of 3d Scanner. b) White Balance of 3d Scanner. c) EXscan SE V2 Software Interface**

Before initiating any specimen scanning operation, the system was calibrated using the original SHINI-NG3D calibration board marked CPCY 2203311676-V200. Following the software prompts, the calibration plate was placed at the designated turntable position and remained fixed throughout the calibration process until the software confirmed successful parameter matching. Afterwards, unified white-balance calibration is performed under a fixed experimental ambient light to correct

The EXscan SE V2 software shown in Figure 6c was activated to build an independent experimental project and input the standard geometric parameters of the tested helical gear in advance. Three differently pre-treated gear samples were sequentially installed on the turntable, with the installation posture carefully adjusted to ensure that the gear rotation axis coincided with the central axis of the turntable.
