Detection of the Possible Engine Damages in Case of a Continuous Track Military Vehicles with Tribological Investigations

The main goal of this article is to present the failure analysis method through the tribological investigation of the engines of two PTSZ-M type medium-tracked amphibious military transport vehicles.

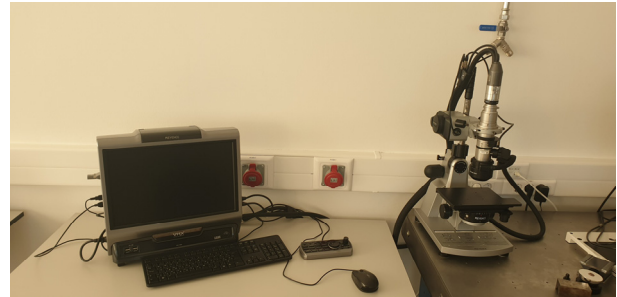
According to the investigations of Paulovics et al. [18], a good correlation can be established between the wear scar diameters and the wear volume measurement, which require a more complex confocal microscope and more time for the microscopical measurements and their evaluation. For our research, a Keyence VHX-1000 type digital microscope (see Figure 4.) was used to measure the dimensions of the wear scars on the contacting surfaces. After the tribological measurements, the wear scars were analyzed to document the wear scar images

Figure 4. Keyence VHX-1000 digital microscope, which was used for measuring the wear scar dimensions on the testing specimens after the tribometer measurements (picture of the authors)

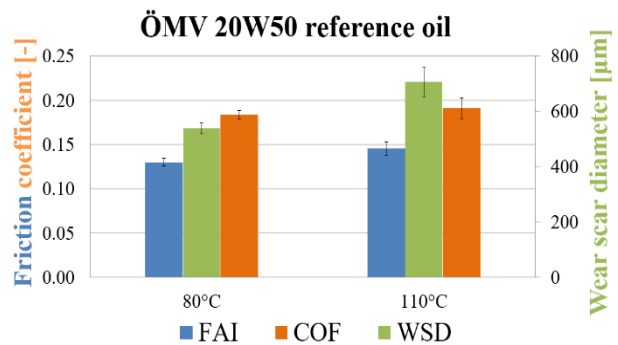
Figure 5. The results of the tribological investigations with the ÖMV 20W50 engine oil used as a reference oil sample (figure of the authors)

The results show a relatively low standard deviation in the case of each measured value (this indicates an excellent reproducibility), and the protection of the contacting surfaces against wear met the expectations.
